MODIFICATIONS
IN AMBIENT AIR-COOLED VAN CONTAINER
FOR TRANSPORTING AGRICULTURAL PRODUCTS
TO OVERSEAS MARKETS

ARS-NE-83
JUNE 1977

By W. G. Kindya 1/

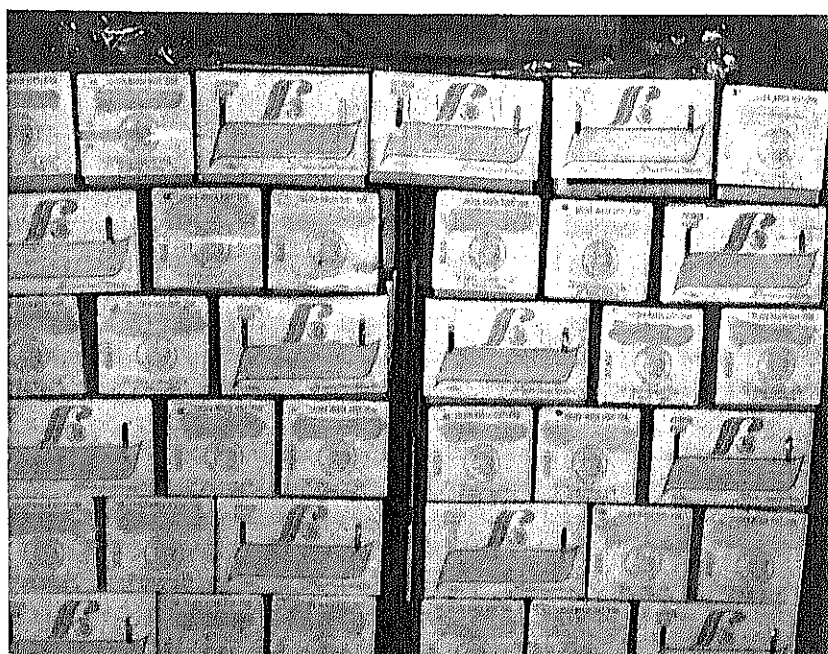
Figure 4.--Cross section view of load in ambient air-cooled van container showing air channel through middle of load and space along sidewall for air distribution in grapefruit test shipment.

The slipsheet units in the ambient air-cooled van container were arranged to provide air channels extending from front to rear to provide air circulation. The first four slipsheet units were placed tightly against the bulkhead and sidewalls to prevent short-circuiting of air from the air inlet to the blower intake. This left a space of about 10 inches between the units at the center of the van container. The remainder of the slipsheet handling units (except the last two at the rear of the van container) were loaded so that a small space of about 2 inches remained between each slipsheet unit and the sidewalls of the van container and about 6 inches between each slipsheet unit at the middle of the load (figs. 4 and 5). The last two slipsheet units were placed tightly against each other at the middle of the van, thus closing off the rear of the air channel at the rear of the load.

The top surface of the load in the air-cooled van container was covered by a sheet of plastic to prevent circulating air short-circuiting the bulk of the load mass. The ambient air was drawn into the van container through the fresh-air intake and flowed downward through the air plenum between the bulkhead and the front end wall of the container. At this point, the ambient air
